Balancing Hydronic Systems in Multifamily Buildings

Russell Ruch, Peter Ludwig, and
Tessa Maurer

Partnership for Advanced Residential Retrofit

July 2014

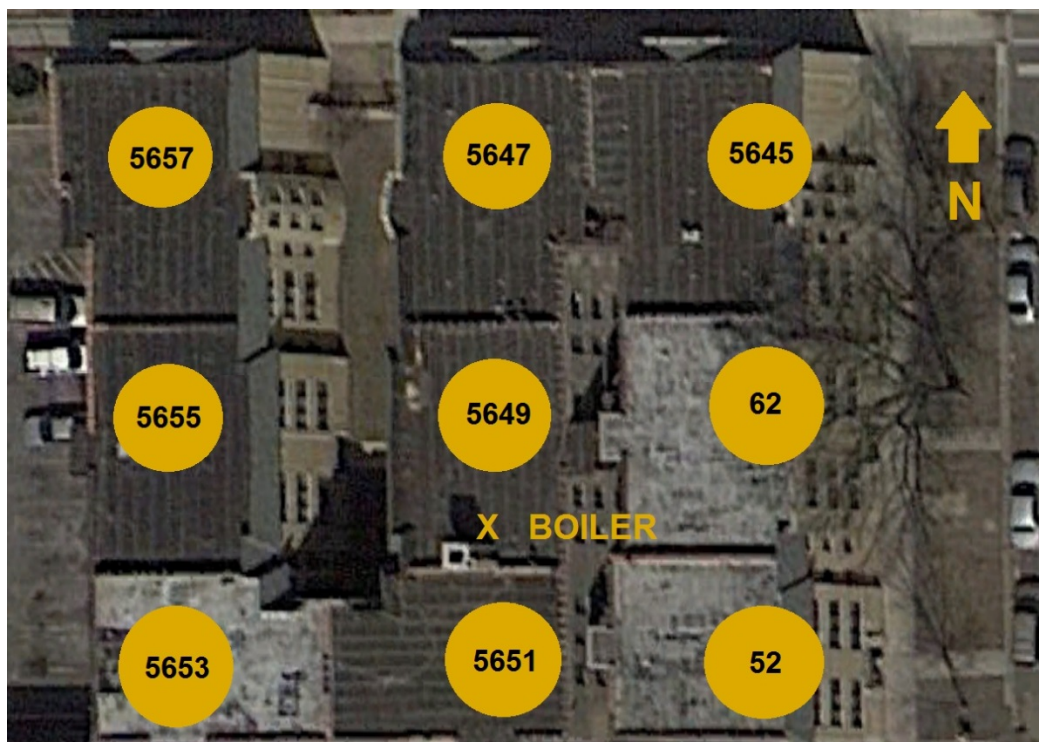
Figure 9. Aerial view of Building A; note position of boiler in southeast corner

Building A (Figure 8) was built in 1920 in an “S” shape typical of Chicago multifamily buildings of that era. Originally outfitted for a steam boiler, the building was converted in the late 1990s to a centrally metered hydronic system with baseboard radiators and multiple sequenced boilers.⁵ This new system was piped for only two zones, west and east, and the distribution piping was undersized. This resulted in chronic underheating issues in the north and west units, which were located furthest away from the boiler room (Figure 9).

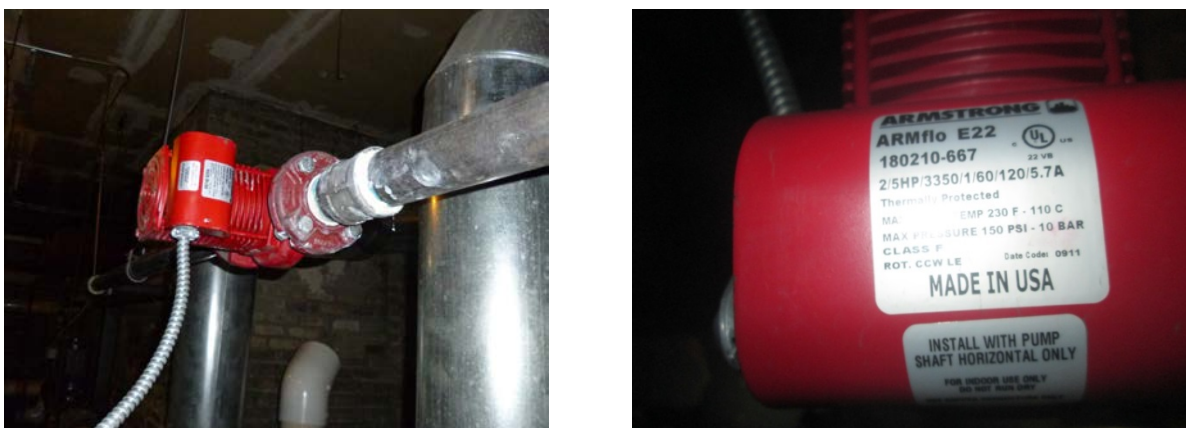
Figure 10. Circulator added to west loop at Building A

In July 2013, building management expressed concerns that despite the new temperature controls the building still had underheating issues in the north and, especially, west units. They noted that uneven heat distribution caused many tenants to open windows or supplement heat with their oven ranges. These temperature-altering actions interfered with the averaging controls to the extent that the cut-in set point had to be set at 79°F in order for the boiler to consistently heat all units to at least 65°F. The high set point resulted in severe overheating of some units, causing significant tenant discomfort and unnecessary gas usage. Ultimately building management decided to bypass the new temperature averaging controls altogether and use only the outdoor reset as the primary firing control.

In August 2013, PARR's heating contractor submitted a proposal for a retrofit to address the imbalance issue. Since replacing the undersized piping would be prohibitively expensive, he recommended adding a booster pump to increase flow to the west loop (Figure 10). This retrofit was expected to address underheating of the furthest units, while allowing maintenance to return to using the temperature averaging controls, ideally at a lower set point temperature. Building management agreed to this proposal and signed a contract on October 1, 2013.

In October 2013 the contractor drained the system and installed isolating valves on the west loop so the pump could be installed in the middle of the heating season (for data comparison purposes) with minimal disruption. Eighteen data loggers were installed throughout the building, comprising a sample of about 50% of units. In November 2013 the contractor installed a boiler gas meter.

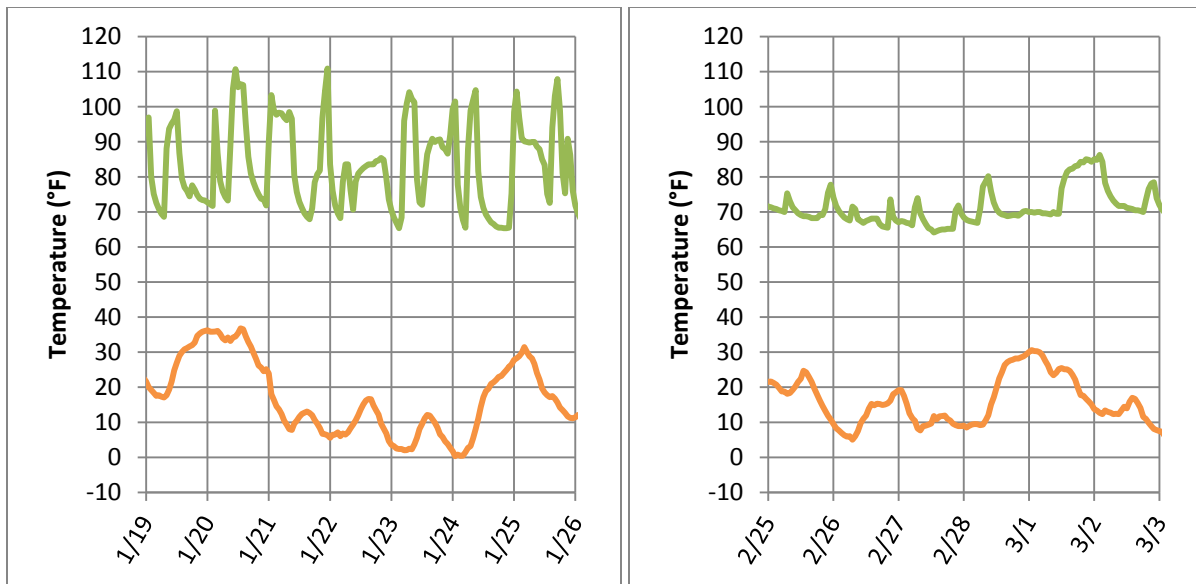
Figure 12. Two weeks of readings at unit 5651-1: pre-retrofit (left); post-retrofit (right)

temperatures and relative proximity to the kitchen suggest that the oven range was used to supplement heat in the unit.

Temperature in the pre-retrofit week oscillates widely within a range of 66°–111°F, cycling one to three times a day. Temperature in the post-retrofit week rises and falls within a relatively narrower range of 66°–86°F, and only rises above 81°F during a single cycle. Outdoor temperatures during these weeks were comparable.

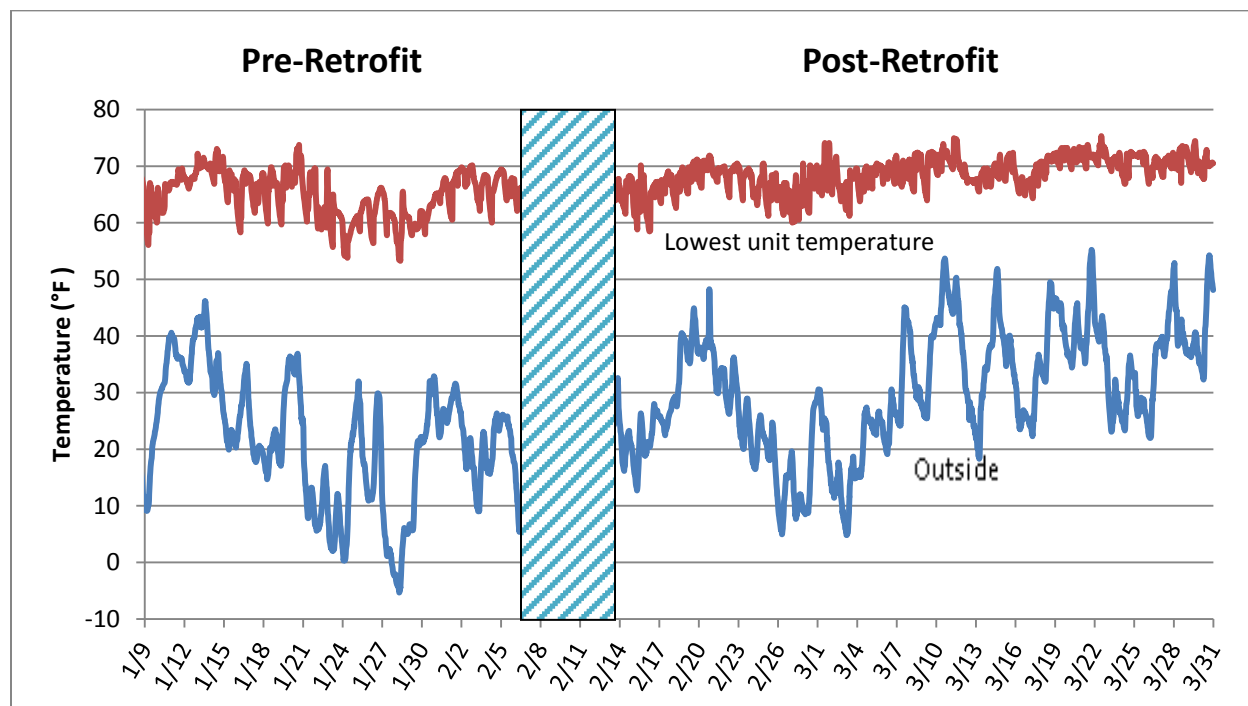
Figure 13. Lowest unit temperature at Building A versus outside temperature

The results indicate that unde-heating became less significant as a result of the retrofit. Minimum recorded temperature rose in nine of the 11 units and dropped by less than 1°F in the other two

units. On average, unit minimum temperature rose by 4.9°F after the retrofit, with the greatest improvement in the west wing unit 5651-1 (9.8°F). Figure 13 plots the minimum recorded unit temperature in Building A at each 30-minute interval over the course of the study period.

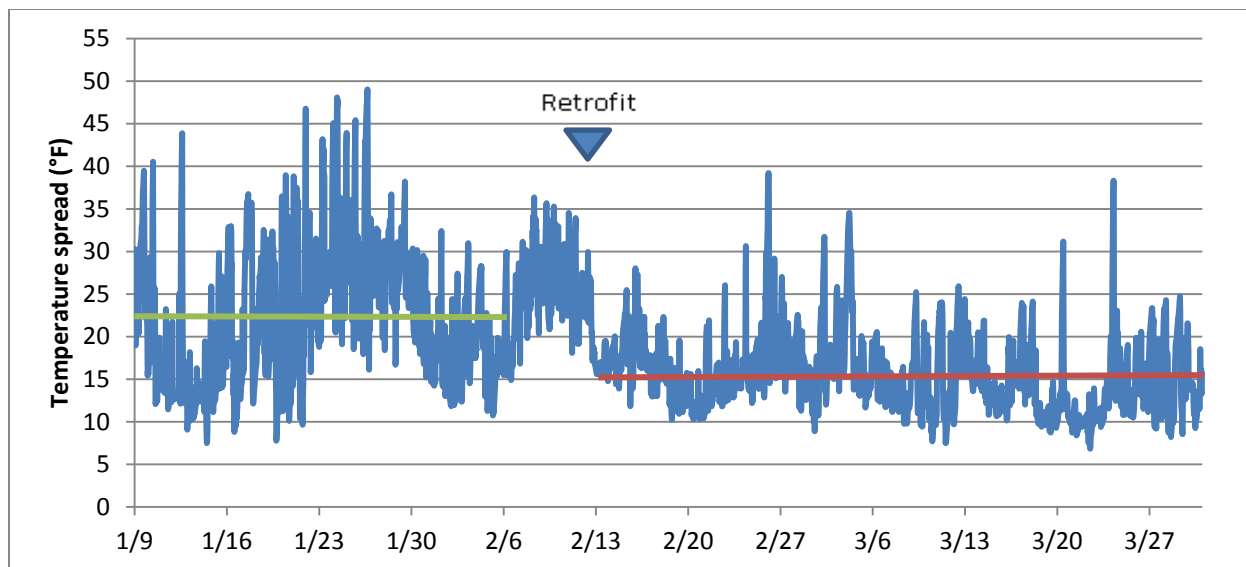
Figure 14. Difference between highest and coldest unit temperatures at 30-minute intervals

Mean differentials for the pre-retrofit and post-retrofit periods showed an improvement in temperature spread from 22.1°F to 15.5°F . This measure of temperature spread is plotted over time in Figure 14. Pre- and post-retrofit averages are shown in green and red.

As Figure 14 visually depicts, not only did the temperature spread across units generally improve after retrofit, but the incidence of temperature differences likely caused by supplemental heating also significantly decreased. This is shown by the relatively few “spikes” in temperature spread after retrofit. Though some tenants likely continued to supplement the baseboard heat, they seem to have been compelled to do so less often.

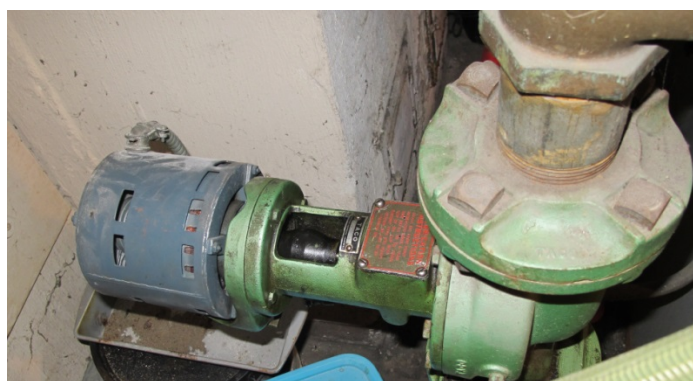
Figure 16. Primary circulator at Building B

At the start of this study, the original 435 MBH boiler from the 1960s was still in use. Apartment unit temperatures were controlled by Honeywell wall thermostats. A Tekmar indoor/outdoor temperature controller was set for the return temperature at 130°F and the outdoor cutout was set at 55°F. A Taco 121-3 pump served as the primary circulator (Figure 16). The owner had also installed a Grundfos UP 15-42 F booster pump on the second floor, to increase flow to the two furthest units. This single-speed pump was controlled by a thermostat in one of those two units, where the tenant had agreed not to change the thermostat setting. As at Building A, centrally metered natural gas energy use intensity was calculated for the building using gas bill analysis and weather normalization. The building averaged 66 kBtu/ft²/year for the 2 years prior to this study, better than 59% of other hot water heated multifamily buildings built after 1960 in the Elevate Buildings program.

During our initial conversation about the study in April 2013, the owner mentioned tenant complaints of overheating on the first floor. This issue had persisted for years despite the zone valves having recently been replaced and significant tenant turnover during that period. The

owner was able to rule out leaky underfloor piping or misreading thermostats as other potential causes. (We were able to confirm the latter in the temperature data we collected.)

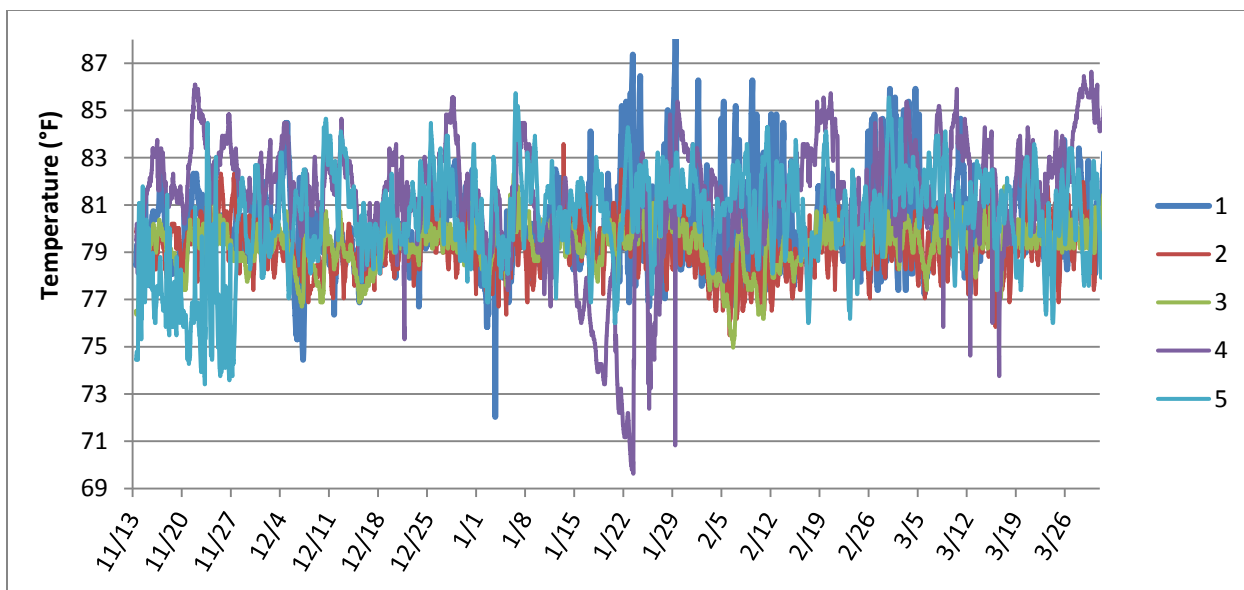
Figure 18. Temperatures in first floor units of Building B

In line with the owner's concern, the first floor did regularly experience higher temperatures than the second floor during the sample period. First floor unit readings were generally ranged between 76°F and 85°F (Figure 18), while on the second floor temperature tended to oscillate between 72°F and 82°F (Figure 19). Note that second floor unit #8 read especially low because the tenant there preferred to set the thermostat at 60°F.
