Balancing Hydronic Systems in Multifamily Buildings

Russell Ruch, Peter Ludwig, and
Tessa Maurer

Partnership for Advanced Residential Retrofit

July 2014

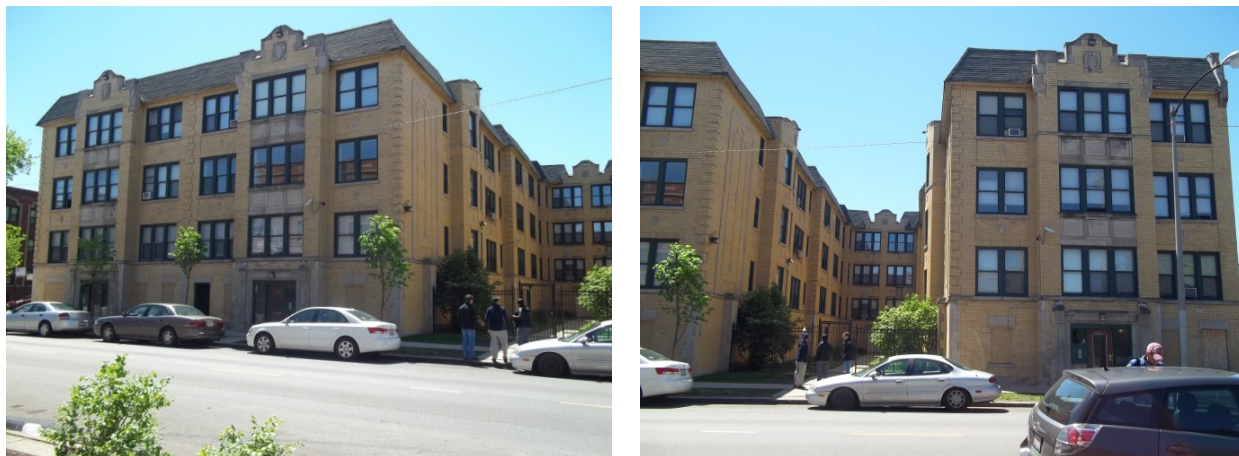
Figure 8. Photograph of Building A: northeast corner (left); northwest corner (right)

Building A (Figure 8) was built in 1920 in an “S” shape typical of Chicago multifamily buildings of that era. Originally outfitted for a steam boiler, the building was converted in the late 1990s to a centrally metered hydronic system with baseboard radiators and multiple sequenced boilers.⁵ This new system was piped for only two zones, west and east, and the distribution piping was undersized. This resulted in chronic underheating issues in the north and west units, which were located furthest away from the boiler room (Figure 9).

In July 2013, building management expressed concerns that despite the new temperature controls the building still had underheating issues in the north and, especially, west units. They noted that uneven heat distribution caused many tenants to open windows or supplement heat with their oven ranges. These temperature-altering actions interfered with the averaging controls to the extent that the cut-in set point had to be set at 79°F in order for the boiler to consistently heat all units to at least 65°F. The high set point resulted in severe overheating of some units, causing significant tenant discomfort and unnecessary gas usage. Ultimately building management decided to bypass the new temperature averaging controls altogether and use only the outdoor reset as the primary firing control.

In August 2013, PARR's heating contractor submitted a proposal for a retrofit to address the imbalance issue. Since replacing the undersized piping would be prohibitively expensive, he recommended adding a booster pump to increase flow to the west loop (Figure 10). This retrofit was expected to address underheating of the furthest units, while allowing maintenance to return to using the temperature averaging controls, ideally at a lower set point temperature. Building management agreed to this proposal and signed a contract on October 1, 2013.

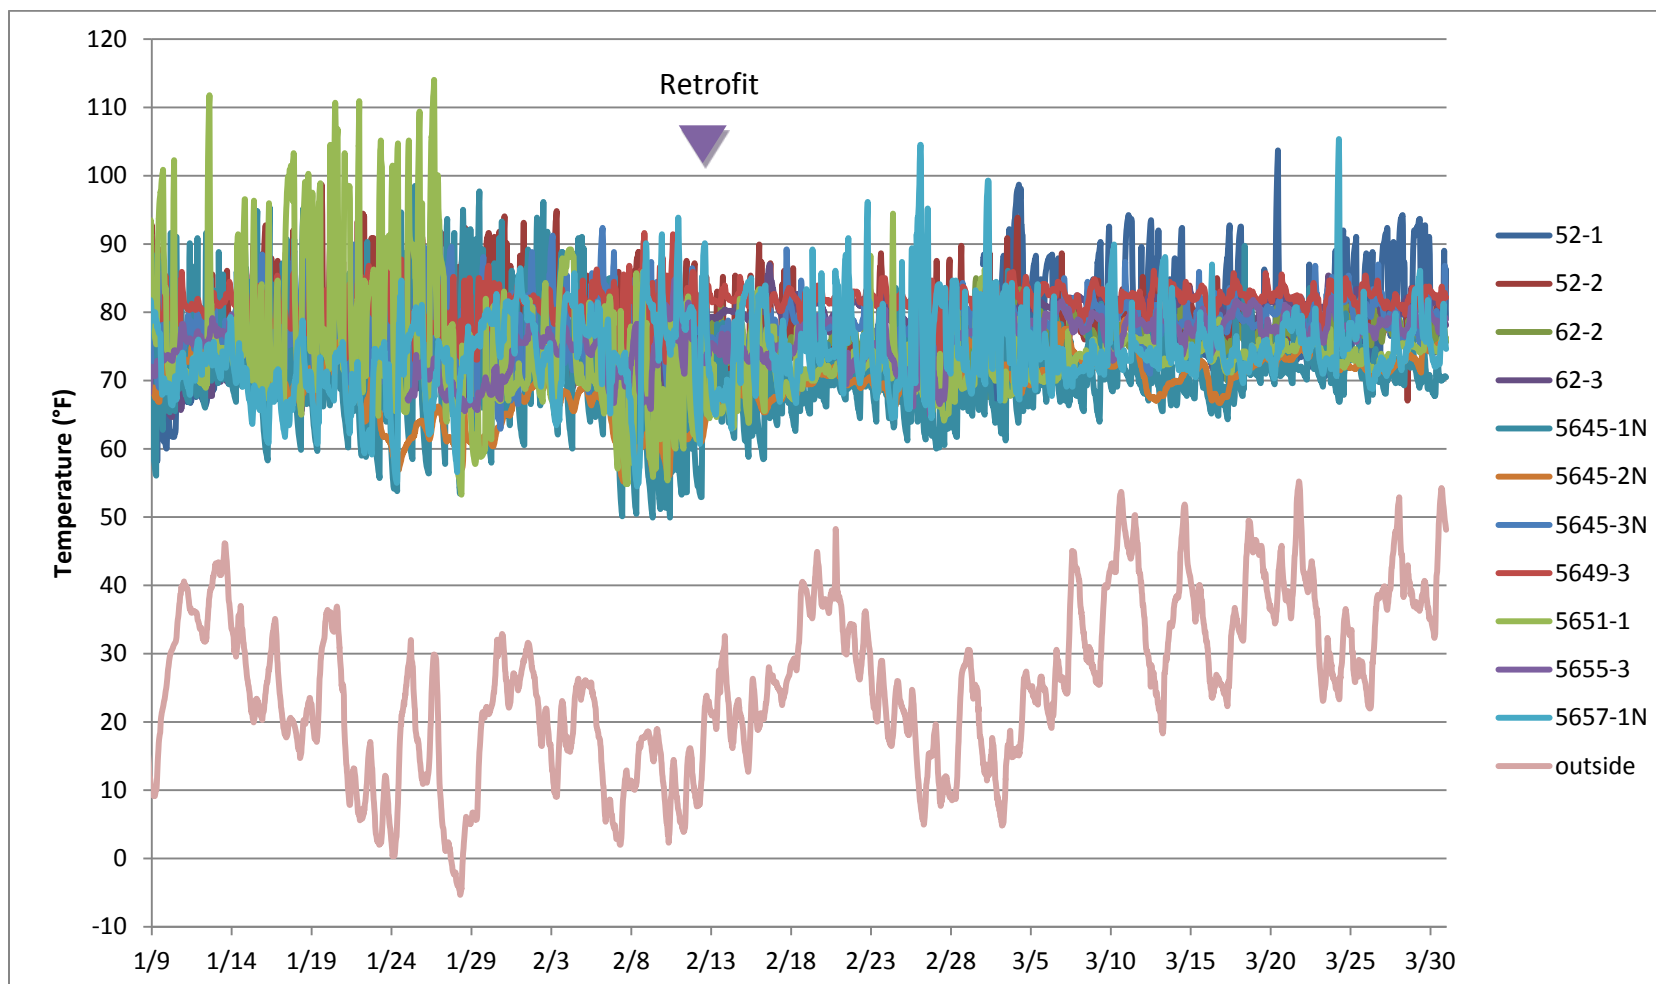
Figure 11. Building A in-unit and outdoor temperatures, pre- and post-retrofit

Temperature in the pre-retrofit week oscillates widely within a range of 66°–111°F, cycling one to three times a day. Temperature in the post-retrofit week rises and falls within a relatively narrower range of 66°–86°F, and only rises above 81°F during a single cycle. Outdoor temperatures during these weeks were comparable.

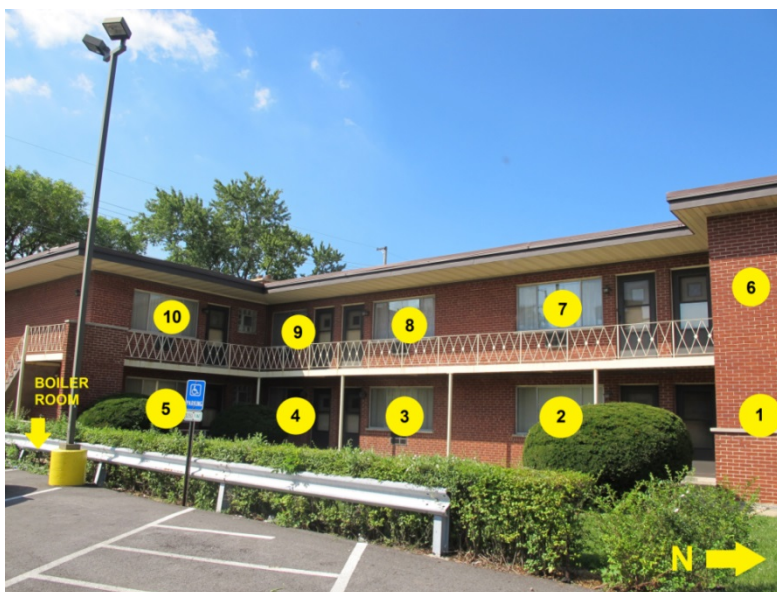
Figure 15. Building B: note location of boiler room

Building B is a 10-unit, two-story, California style building constructed in 1961. Roughly arranged in an "L" shape with five units on each floor (Figure 15), the building uses an underfloor radiant heating system with individual zones for each apartment. The boiler room is located in a basement in the southeast corner.¹¹

During our initial conversation about the study in April 2013, the owner mentioned tenant complaints of overheating on the first floor. This issue had persisted for years despite the zone valves having recently been replaced and significant tenant turnover during that period. The

owner was able to rule out leaky underfloor piping or misreading thermostats as other potential causes. (We were able to confirm the latter in the temperature data we collected.)

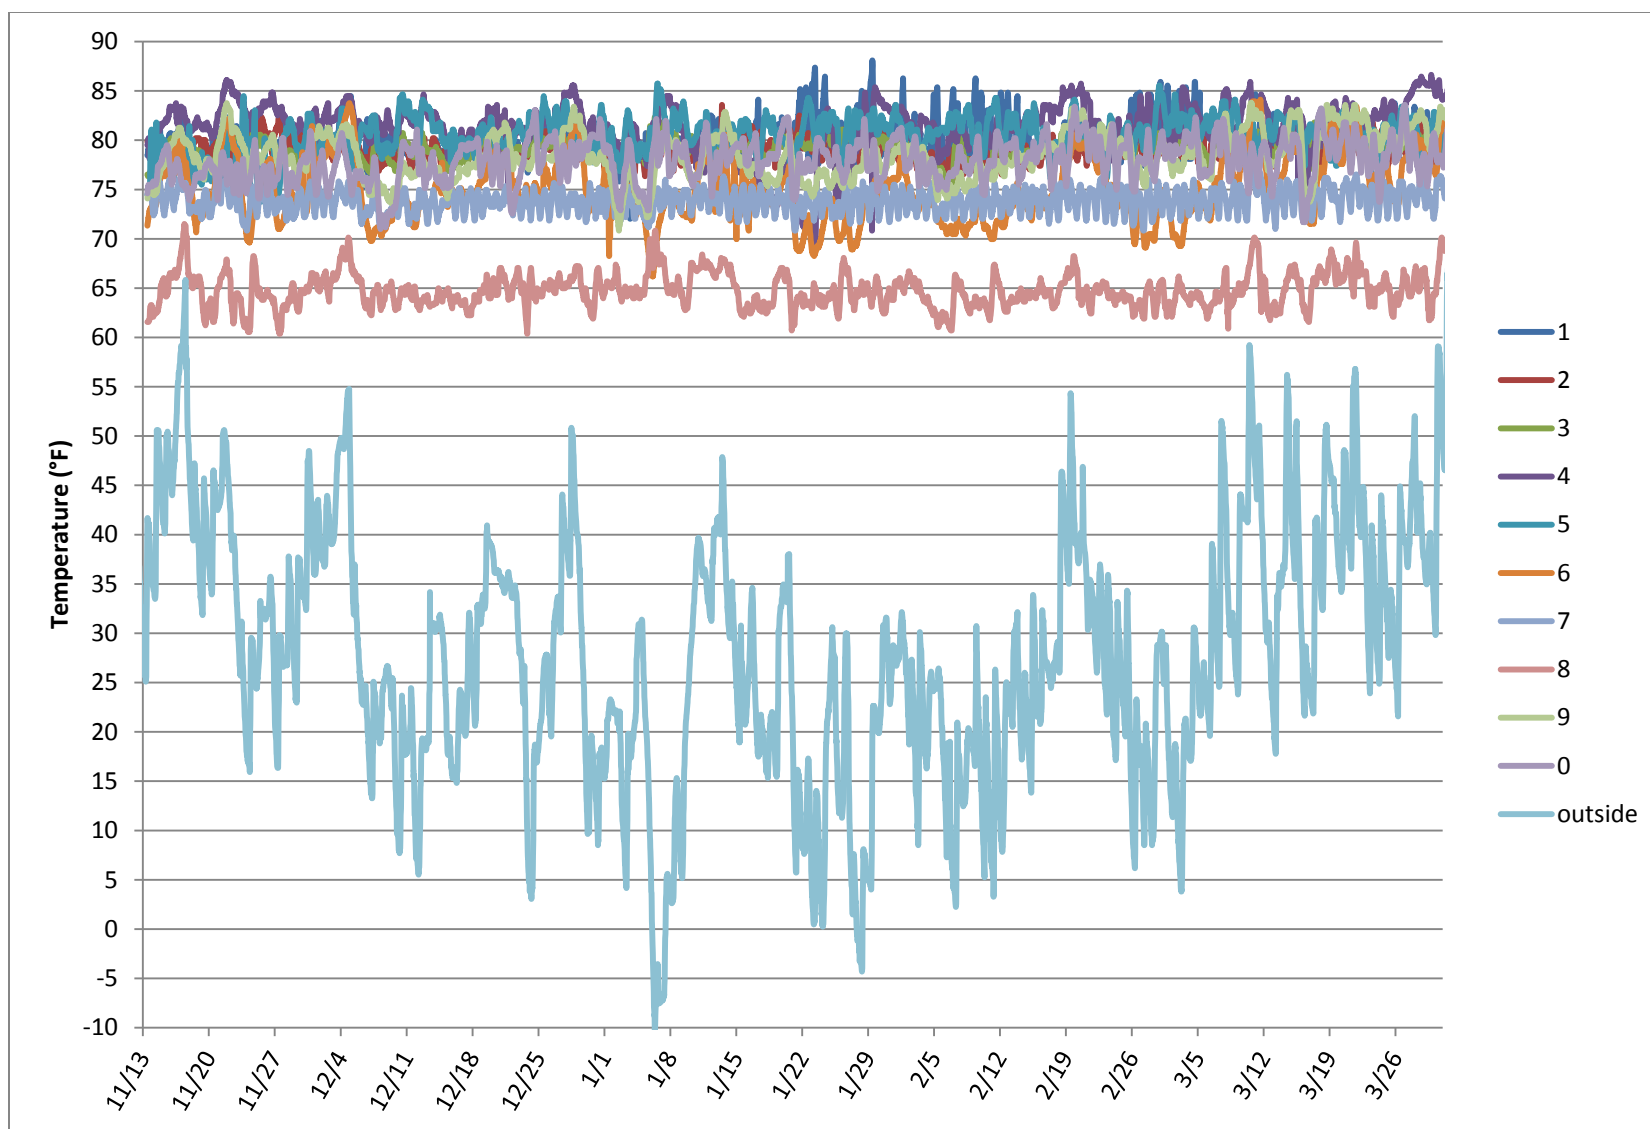
Figure 17. Temperatures collected at Building B

Temperatures at Building B were significantly less volatile and wide ranging than those at Building A (Figure 17). The narrower band of temperatures in building B can be attributed to various factors, including the separate zones for each unit, more appropriately sized piping, its smaller building footprint, and the overall higher level of attention and maintenance paid by the owner of Building B to the heating system there.

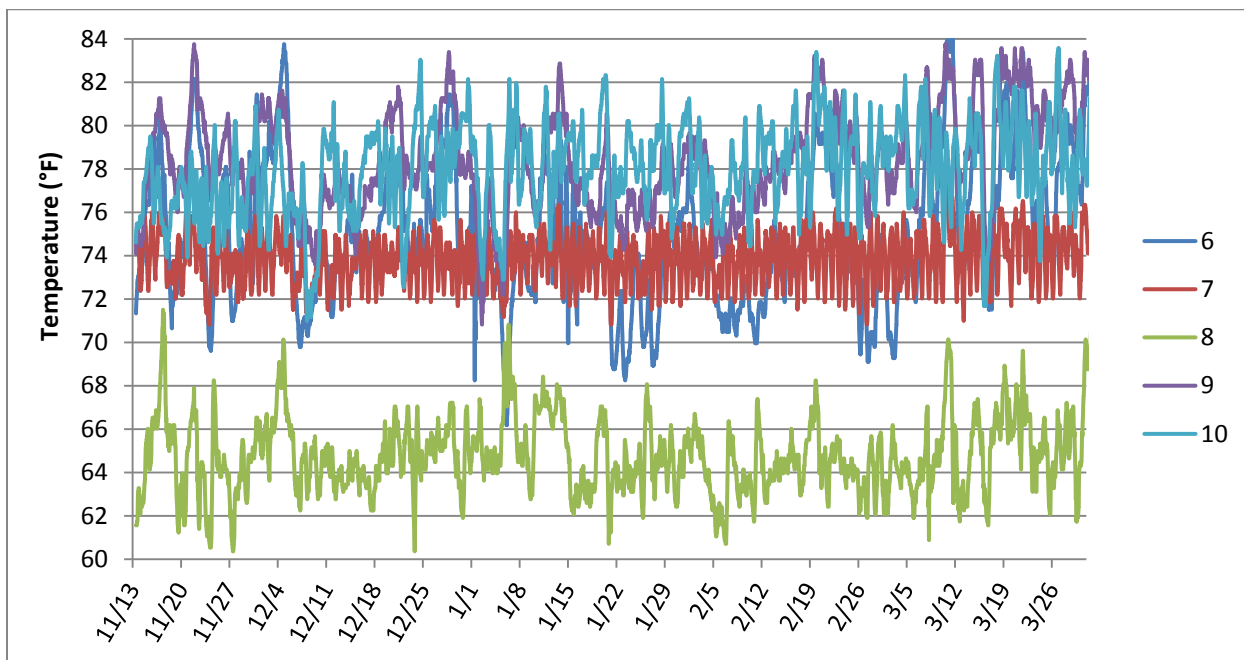
Figure 19. Temperatures in second floor units of Building B

In line with the owner's concern, the first floor did regularly experience higher temperatures than the second floor during the sample period. First floor unit readings were generally ranged between 76°F and 85°F (Figure 18), while on the second floor temperature tended to oscillate between 72°F and 82°F (Figure 19). Note that second floor unit #8 read especially low because the tenant there preferred to set the thermostat at 60°F.

These figures confirm the higher first floor temperatures seen in Figure 18 and Figure 19. Median temperatures in the first floor units were 79.2°–81.6°F (mean 80.1°F), while the second floor unit medians were 64.7°–78.3°F (mean 73.9°F). These ranges indicate a moderate temperature disparity between floors, but they are not proof of imbalance. Since units were individually zoned, it is possible that first floor tenants could have had higher thermostat set points than those on the second floor. Set points are dealt with in Section 3.4.3.3.

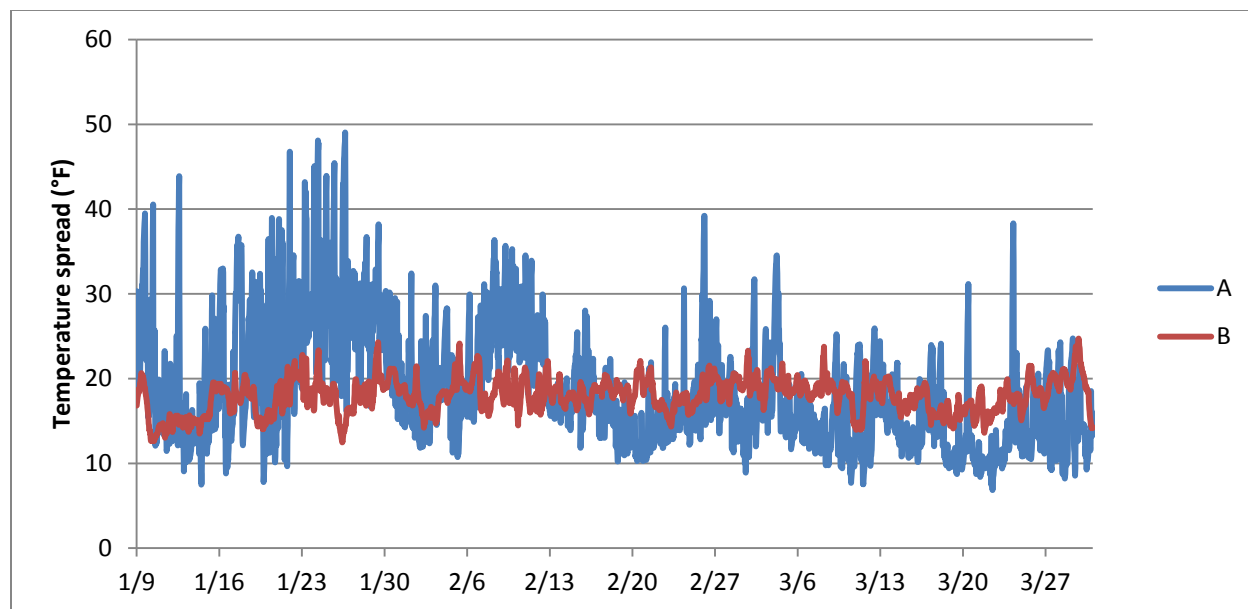
Figure 20. Temperature spreads at both buildings

Figure 20 compares the temperature spread at each building over the sample period. The temperature spread at Building B was clearly less volatile than that at Building A, indicating a more evenly heated building where intermittent supplemental heating in the units occurred less frequently. However, spread was not always lower than at Building A, reflecting the unit-specific zoning in Building B, which allowed tenants to change their unit temperatures to some extent.
